**US Army Corps  
of Engineers**

New Orleans District

# CULTURAL RESOURCES SURVEY OF FOUR CONSTRUCTION ITEMS BELOW NEW ORLEANS

Final Report

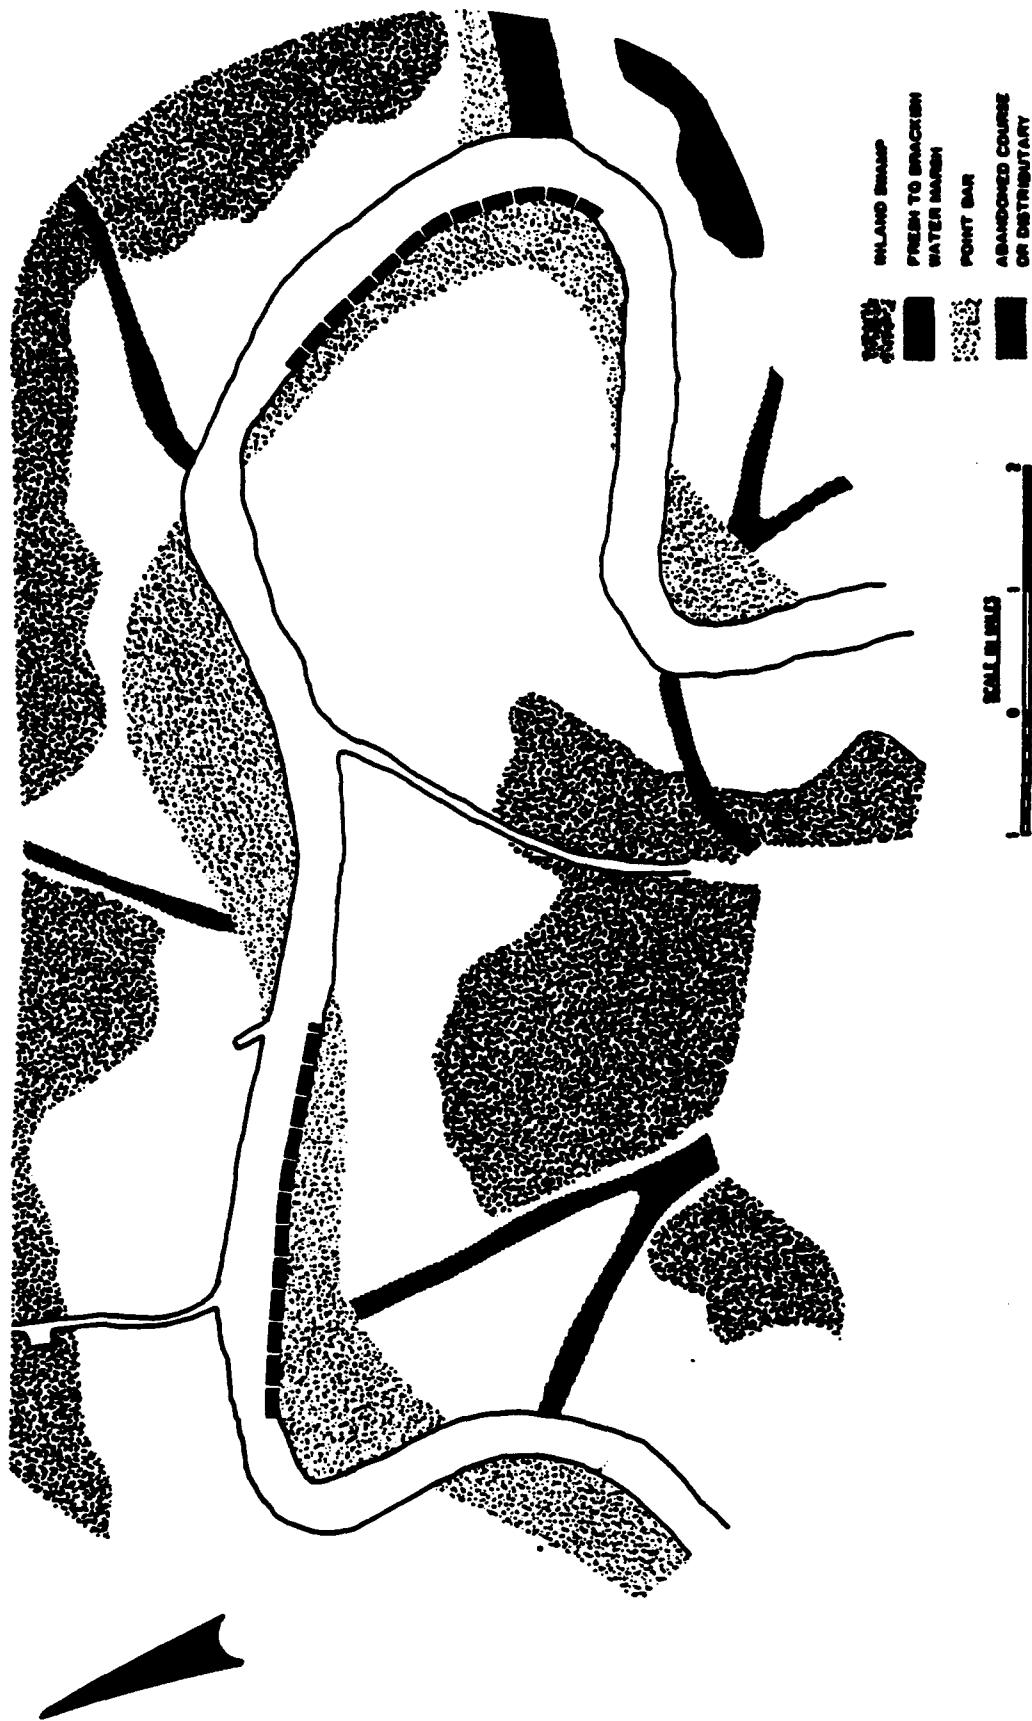
Figure 3. Geomorphic environments of the Mississippi River in the vicinity of the project area (after Kolb 1962). The dotted lines indicate the project area.

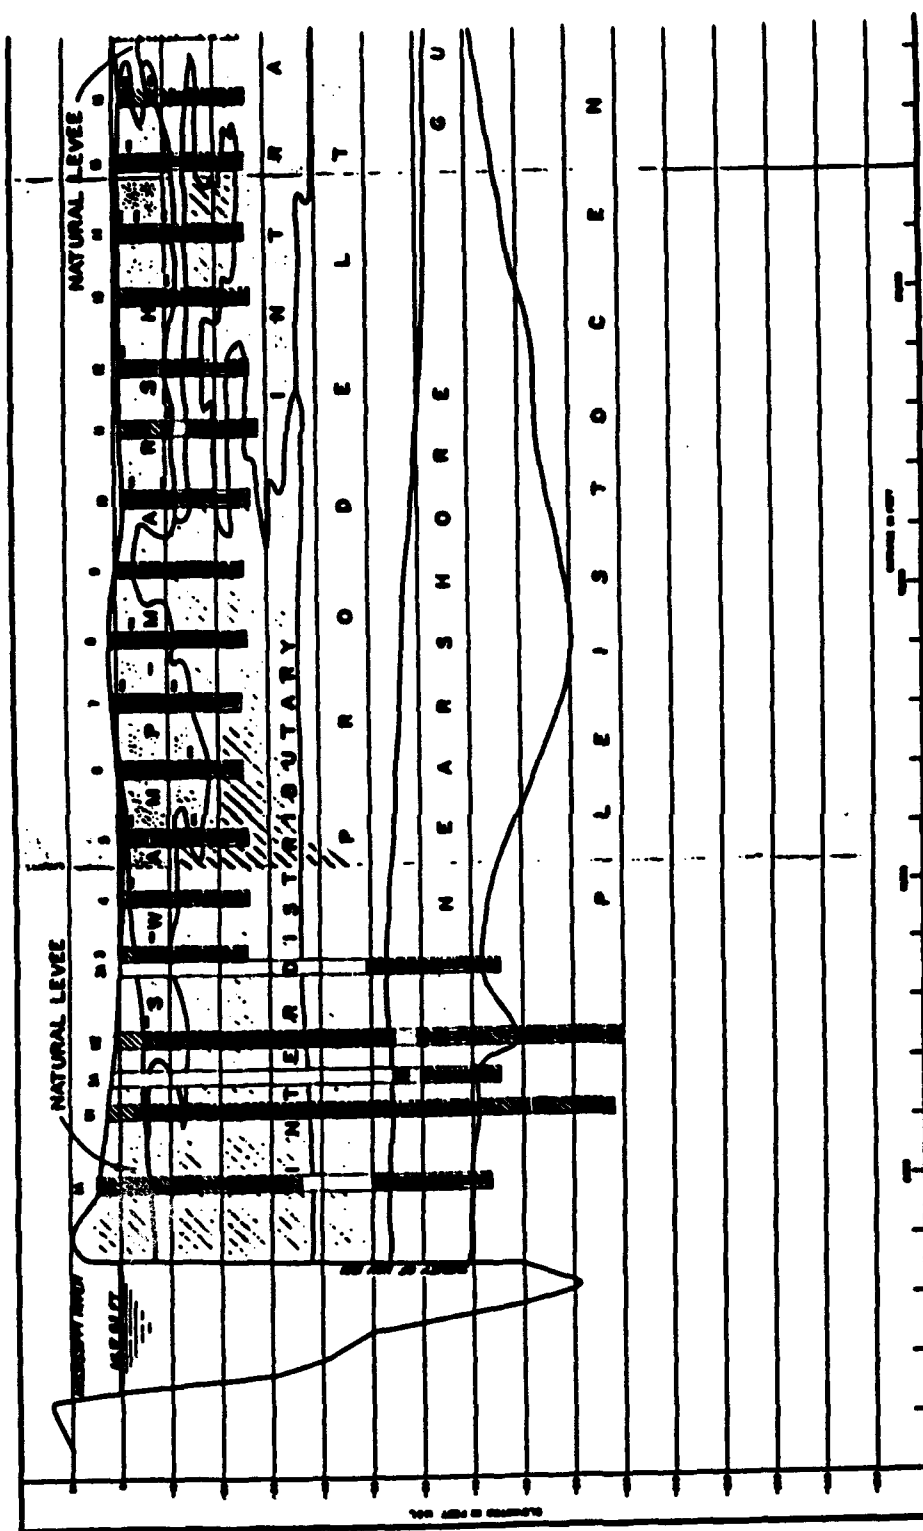
Figure 4. A geologic cross-section of environments along the Mississippi River in the vicinity of the project area (from Kolb 1962).

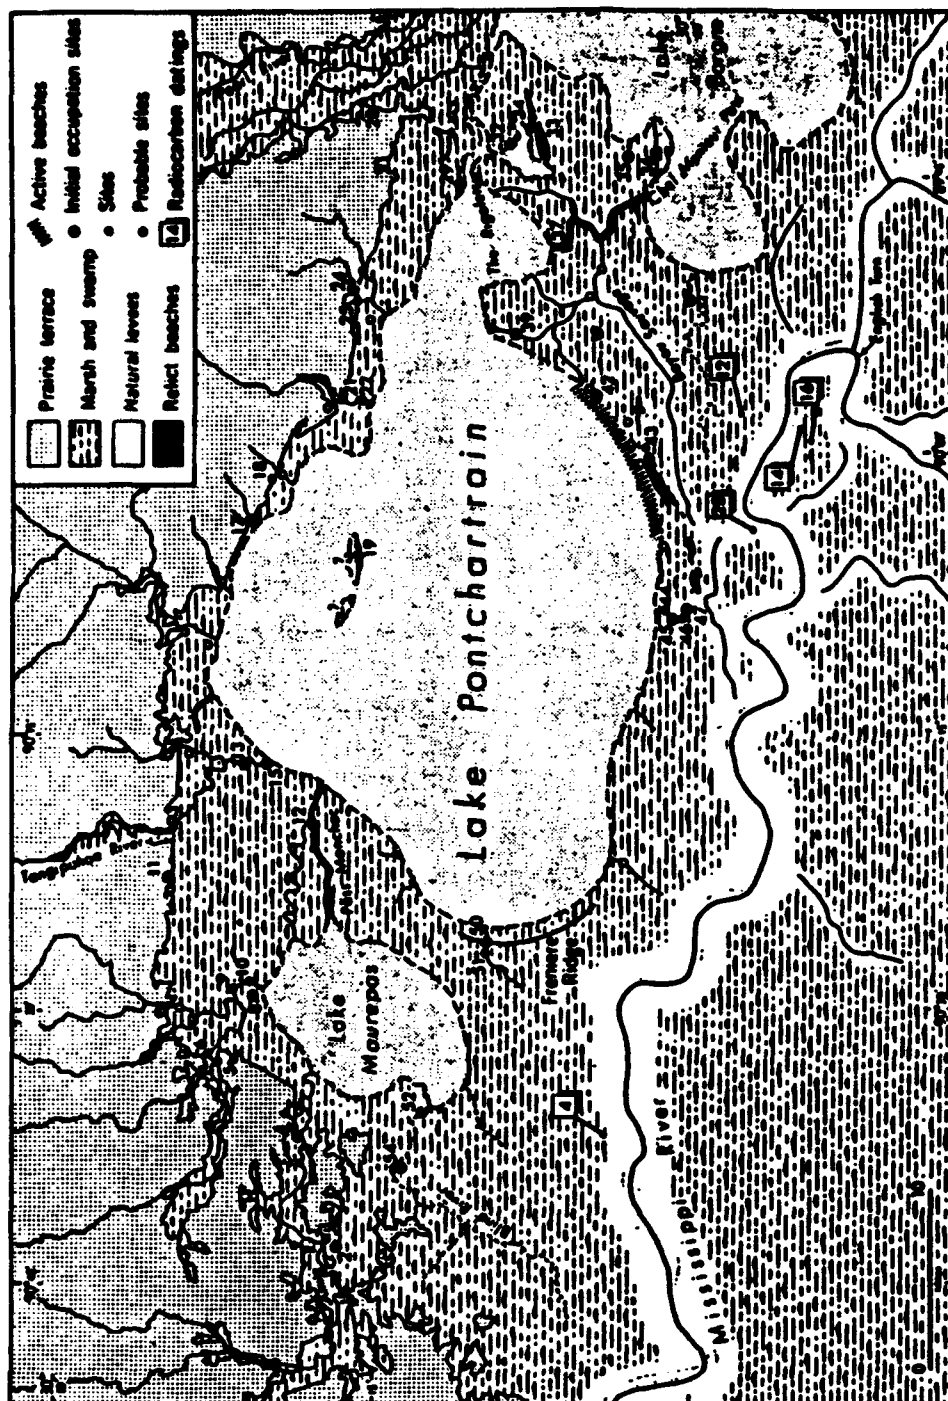
Figure 5. Geomorphic environments and locations of C-14 samples associated with the establishment of the modern river course that were collected in the vicinity of the project area (from Saucier 1963).

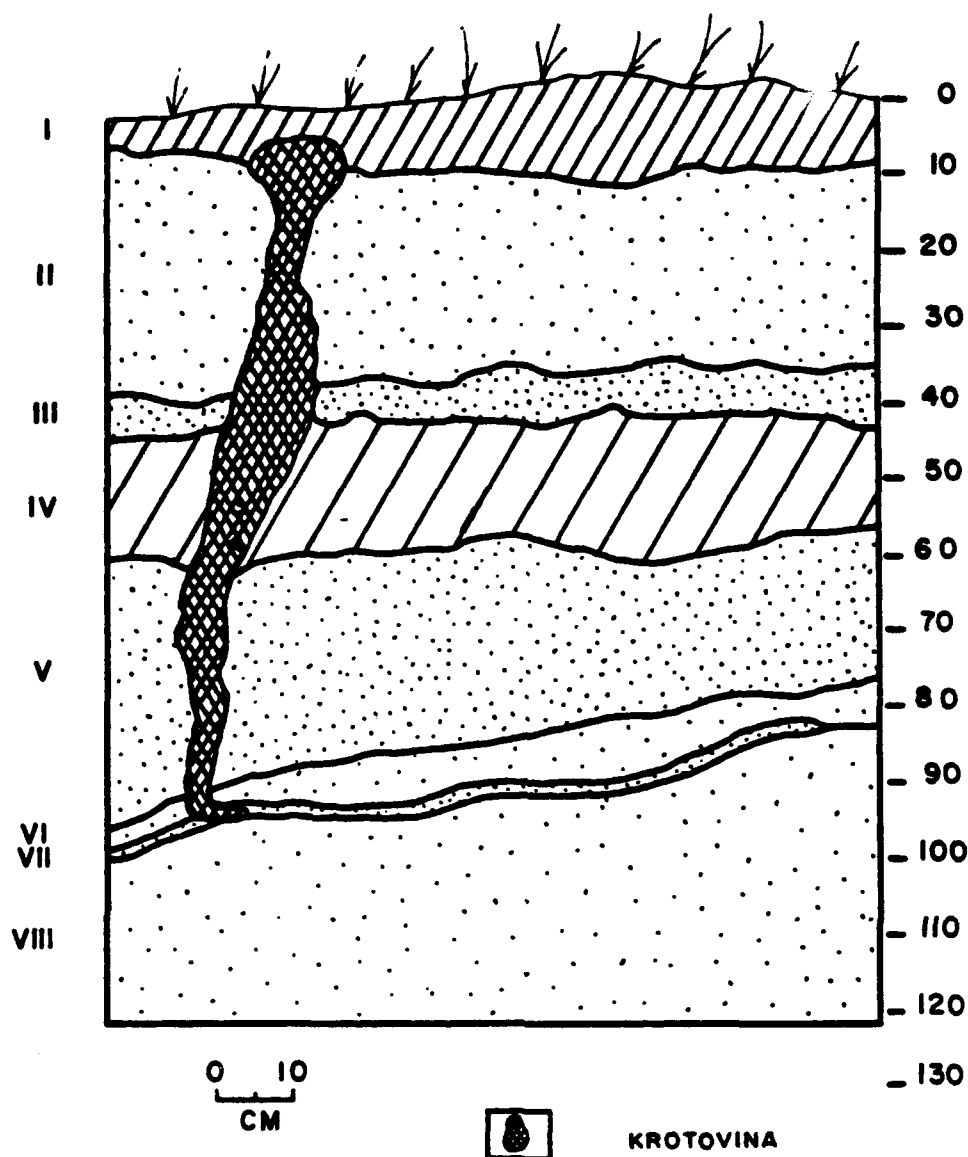
Figure 40. Stratigraphy in Bench Profile No. 1, 16OR119.

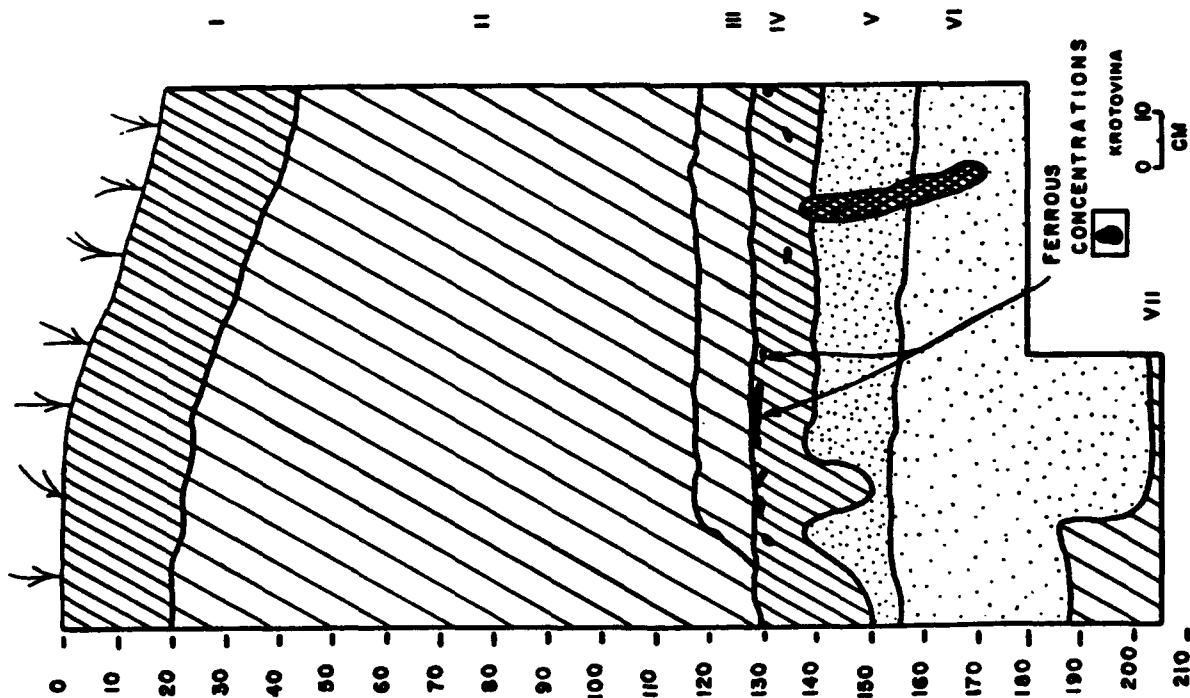
Figure 41. Stratigraphy in Bench Profile No. 2, 16OR119.

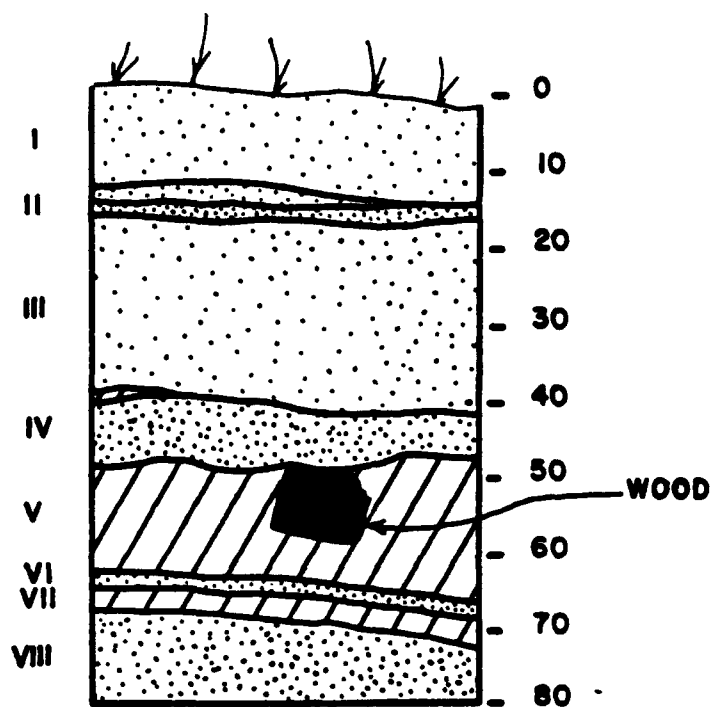
Figure 42. Stratigraphy in Bench Profile No. 3, 16OR119.

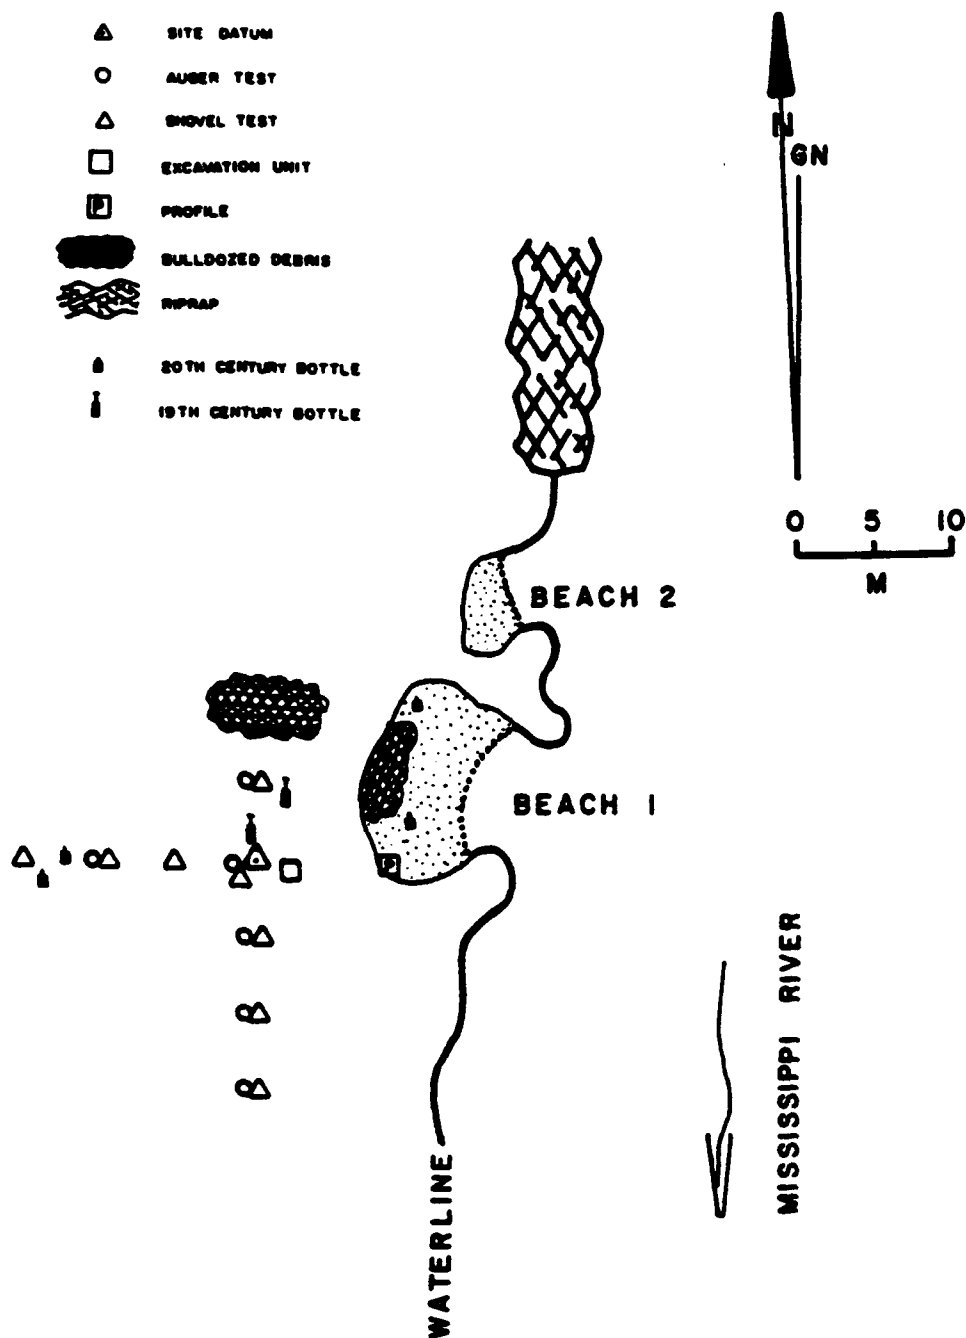
Figure 44. Site Map of 16OR120.

Finally, a stepped profile was cleaned on the bench face associated with Beach 1 (Figure 44). The profile provided 110 cm of vertical exposure. Strata within this profile are depicted in Figure 46, and the key to that figure provides soil descriptions. Interestingly, the basal stratum in this profile was the same as the basal stratum for the auger test excavated in the floor of the 50 x 50 cm unit. This is evidence for a uniform substratum throughout the site.

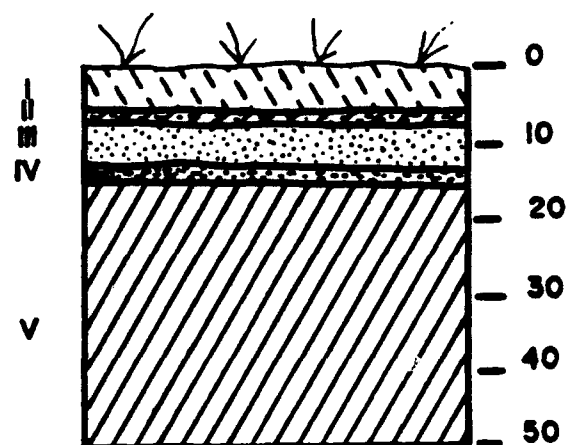
Figure 45. North Wall Profile of the 50 x 50 cm Excavation Unit at 16OR120.

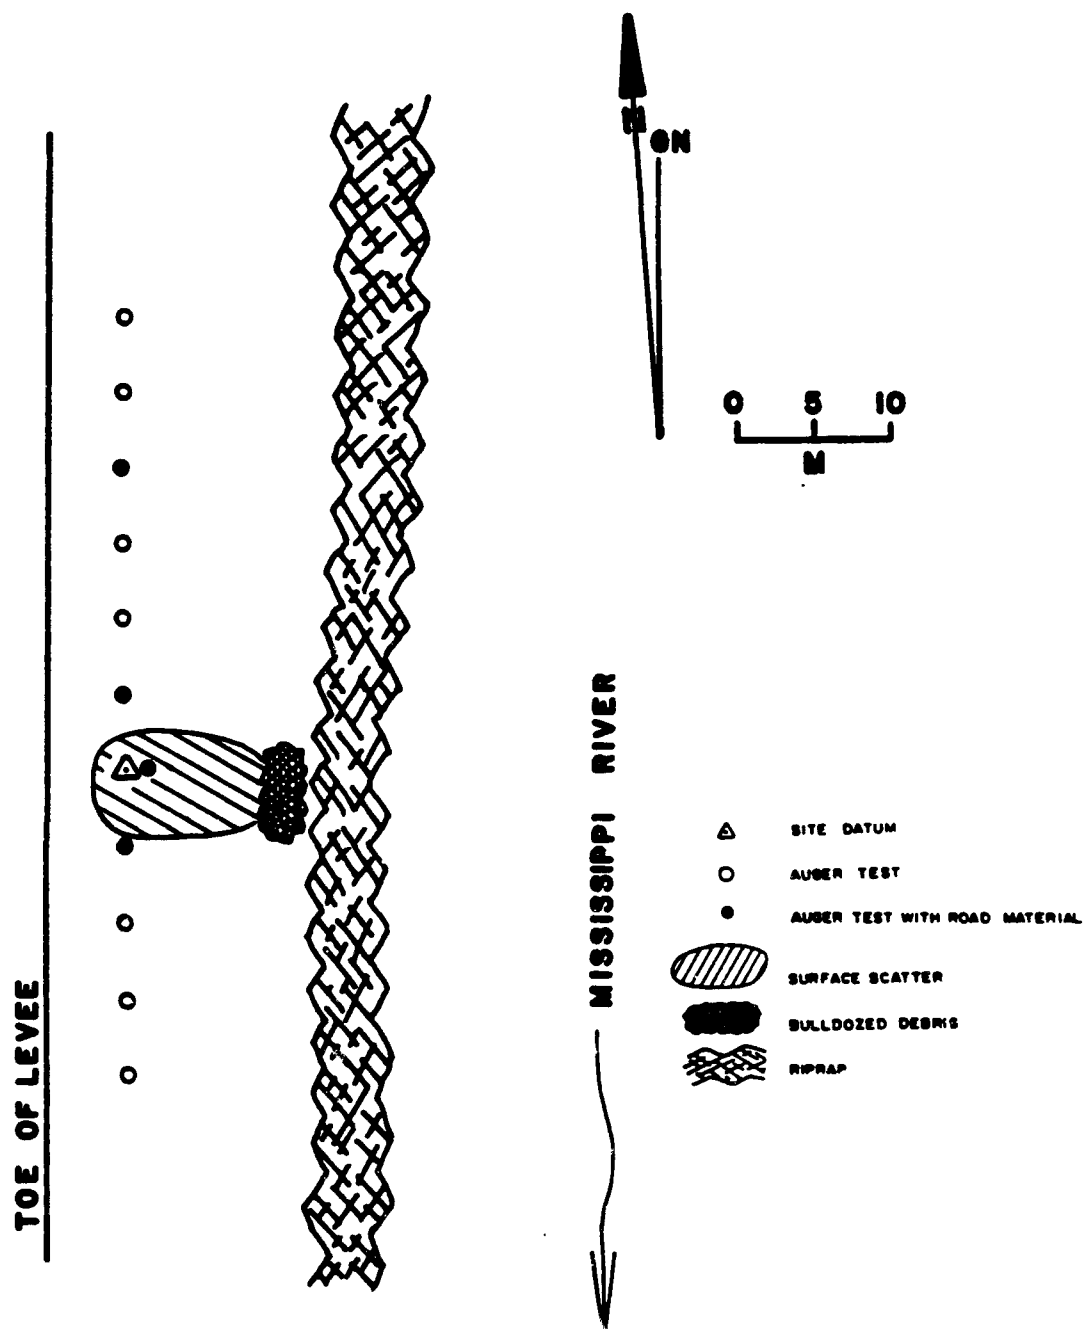
Figure 47. Site Map of 16OR121.

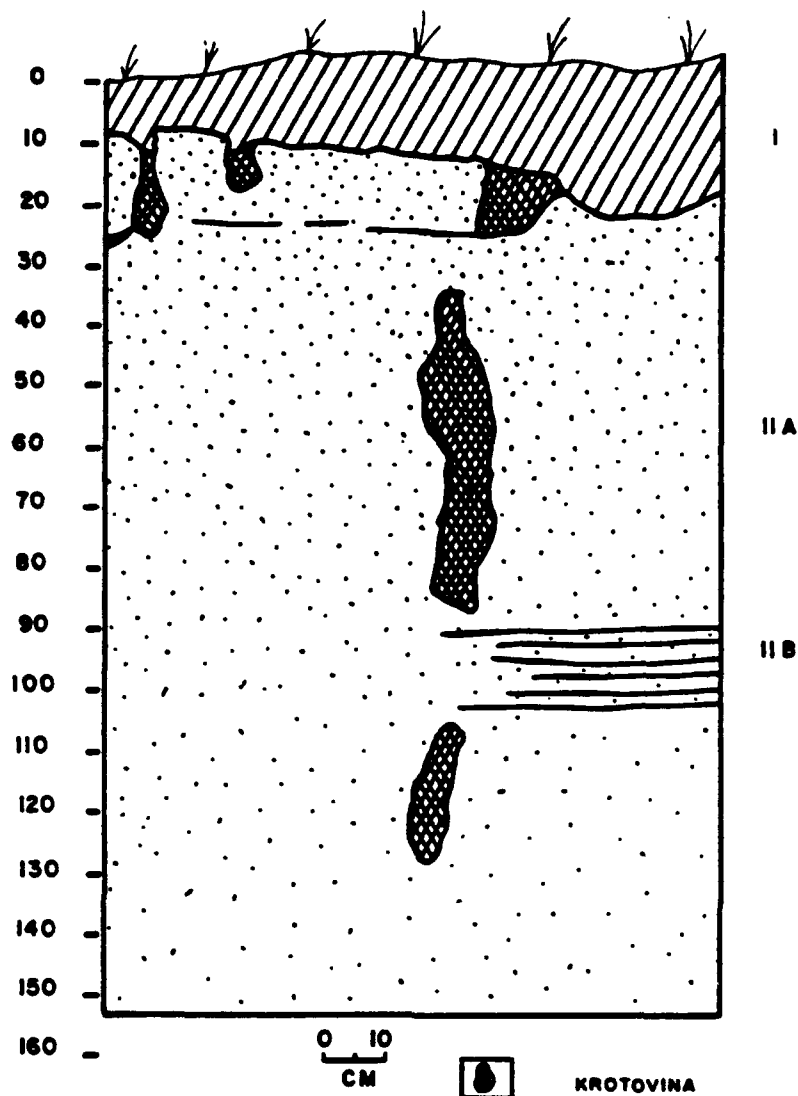
Figure 49. Profile One from 16OR122.

**Bench Face Profiles.** One profile (Profile One, Figure 49) was cleaned on the bench face associated with the beach that yielded historic period sherds. It provided approximately 155 cm of vertical exposure. A second profile (Profile Two, Figure 50) was cleaned on

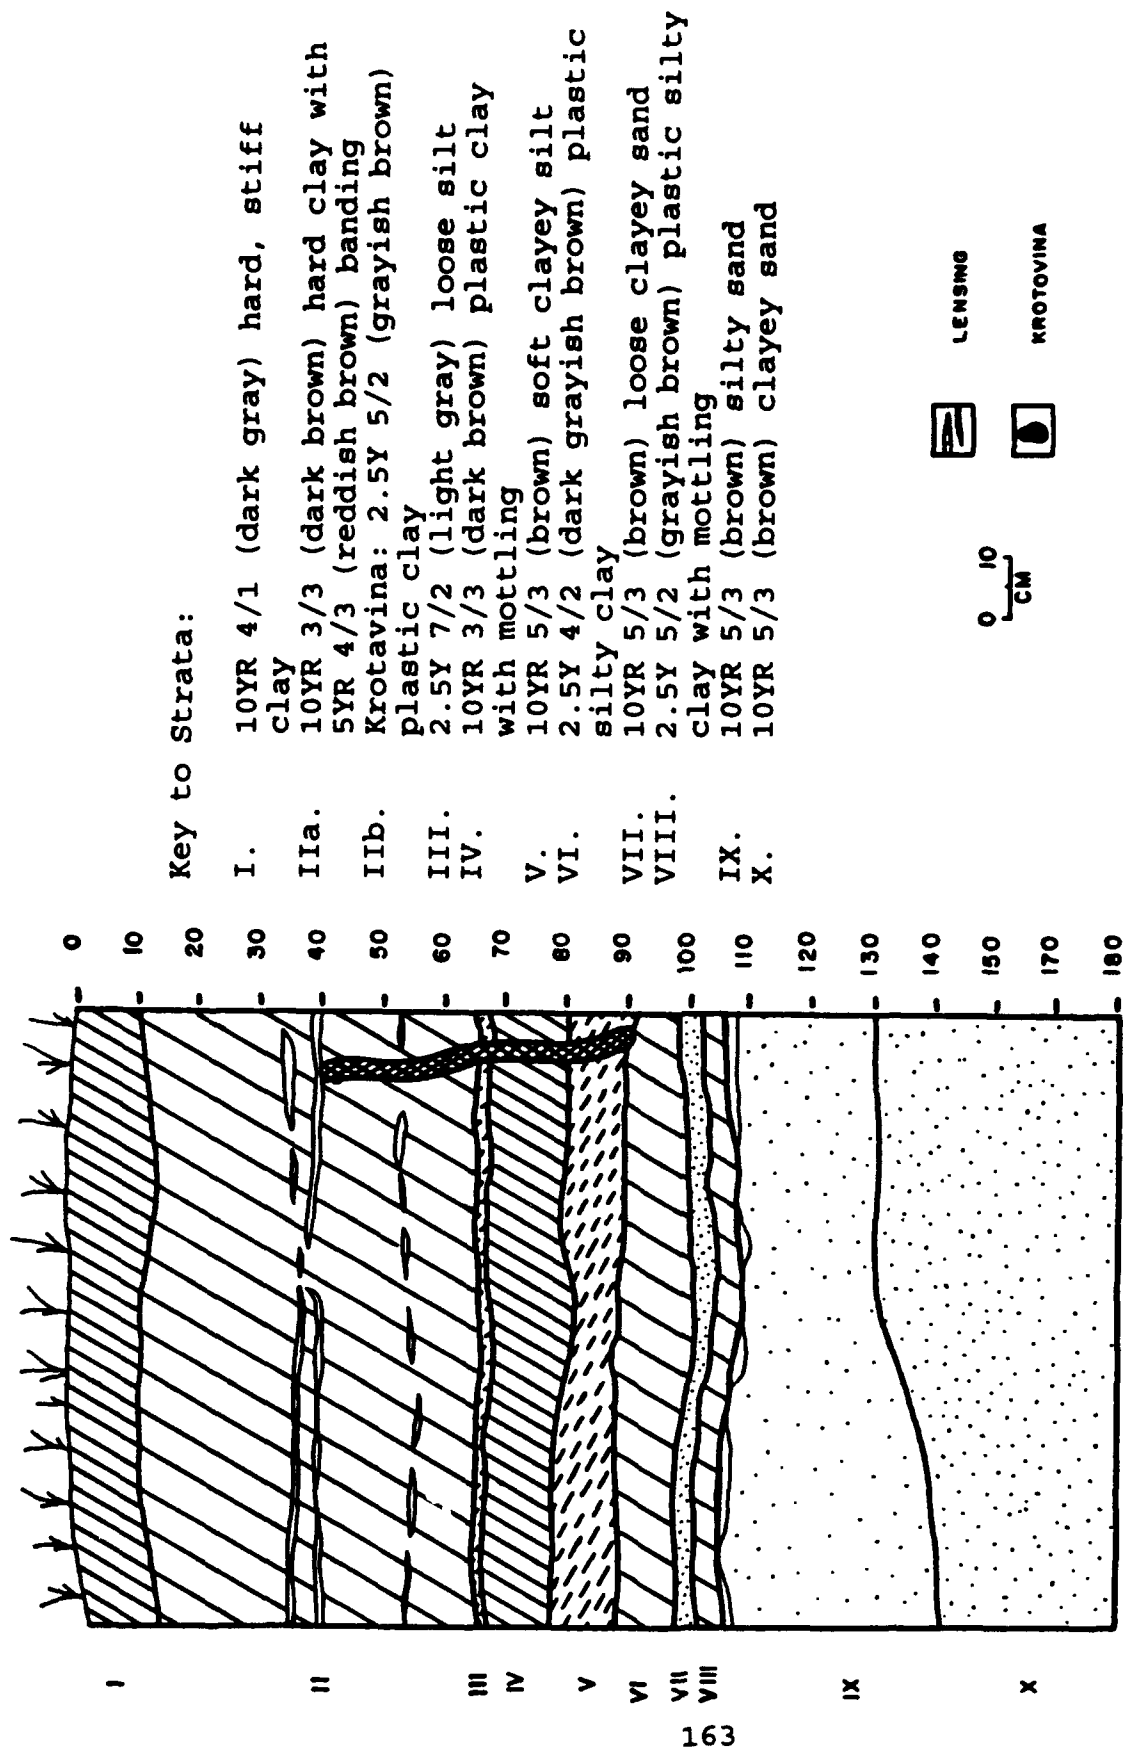
Figure 50. Profile Two from 16OR122.

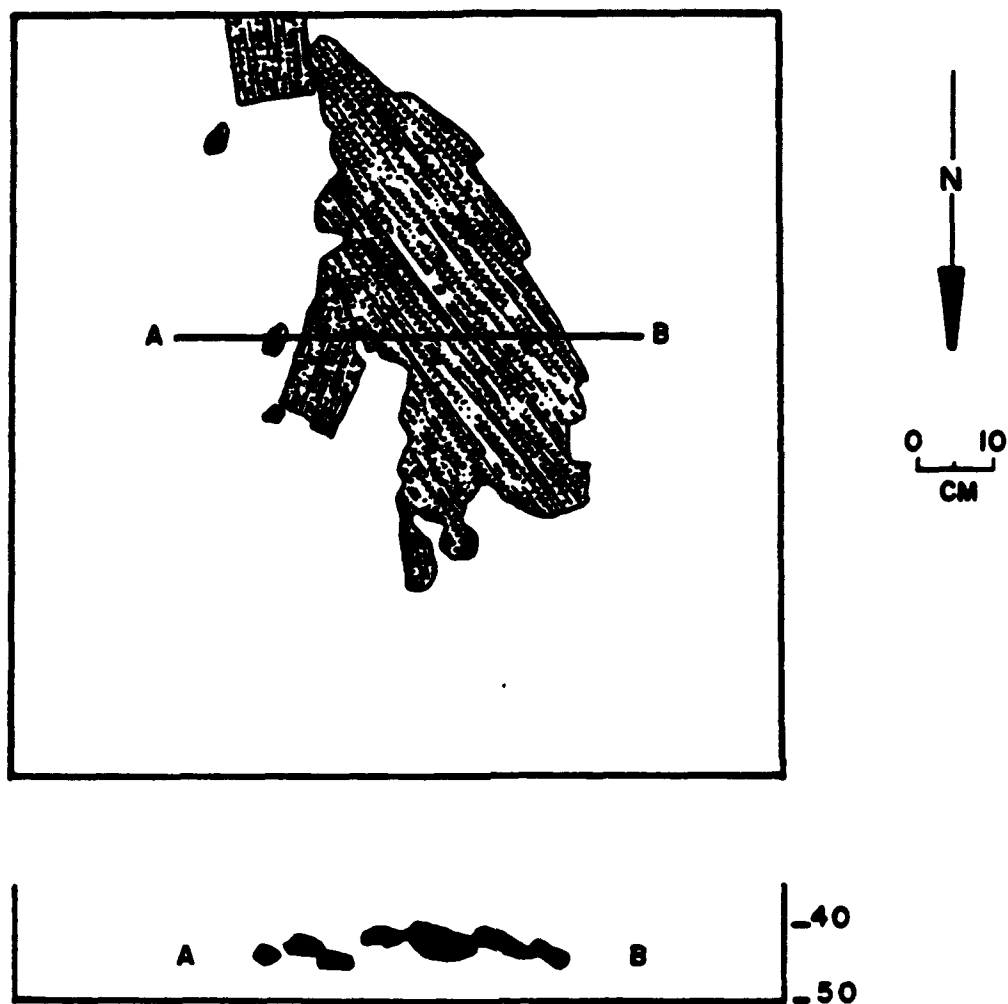
Figure 51. Burned Feature within Excavation Unit at 16OR122, shown in plan view and in cross-section at 50 cm below surface.

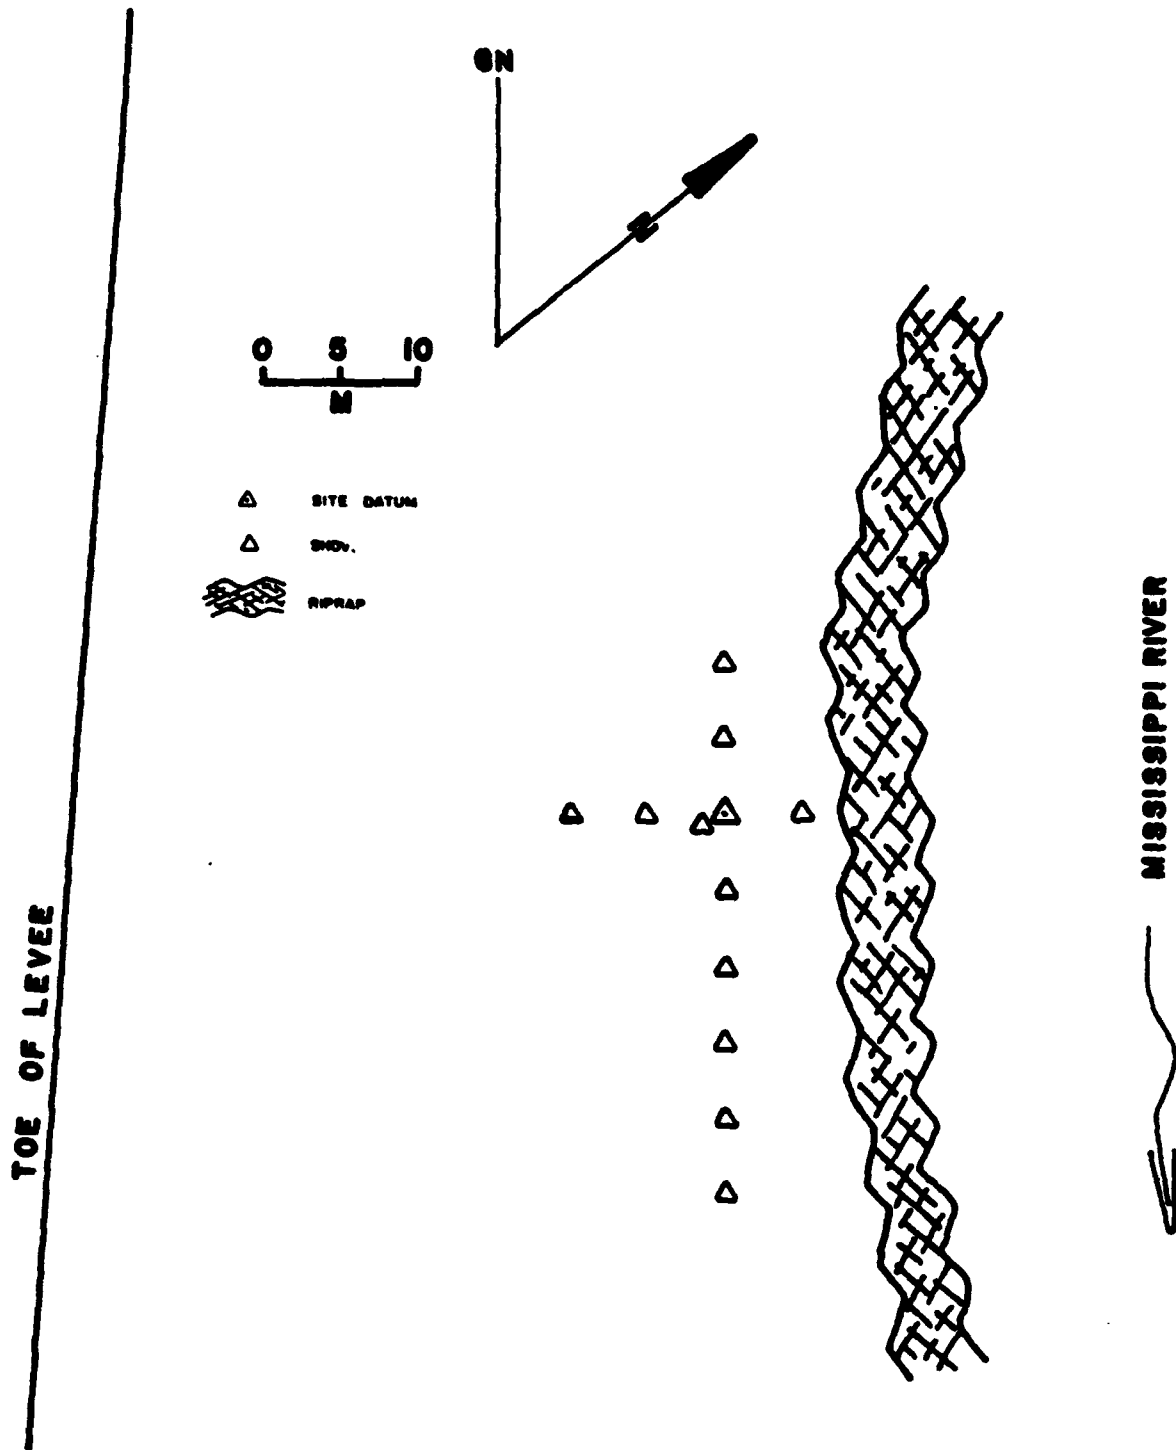
Figure 54. Site Map of Algiers Locale No. 1.

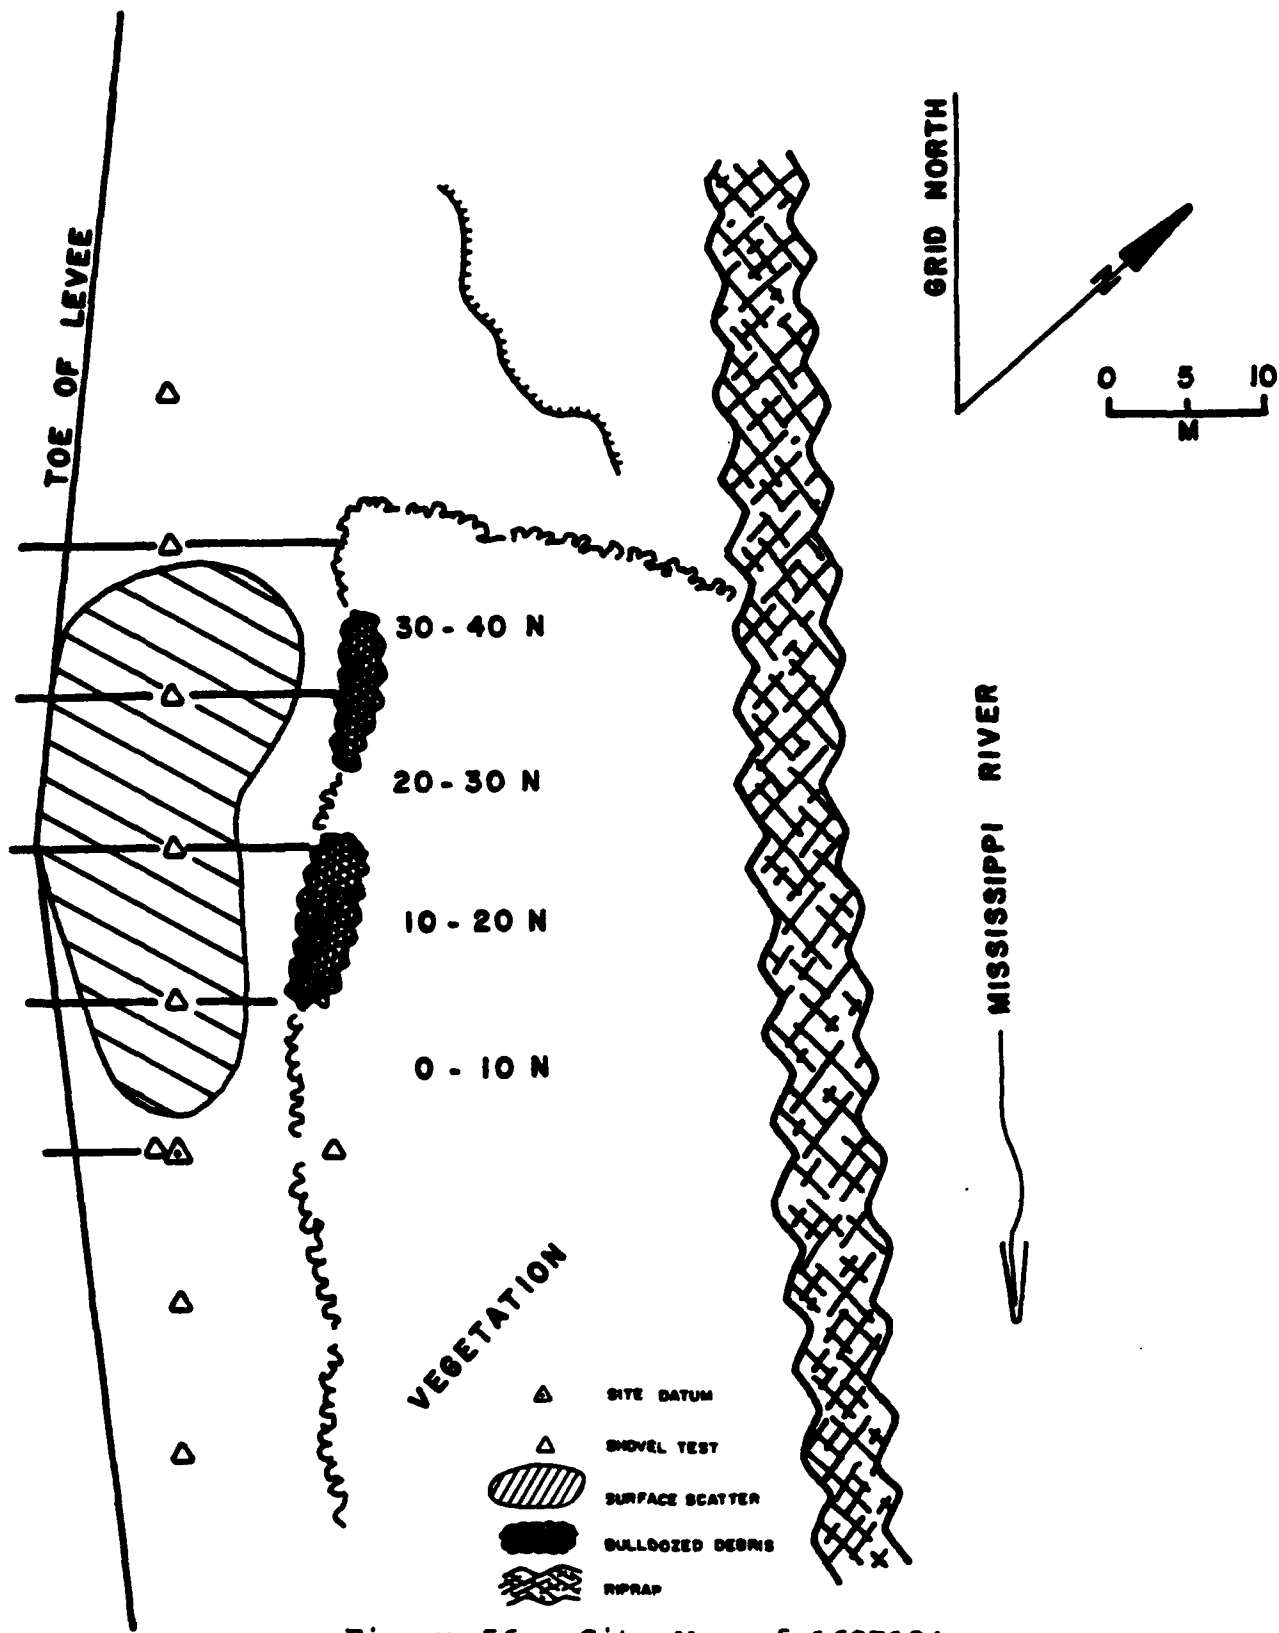
Figure 56. Site Map of 16OR124.

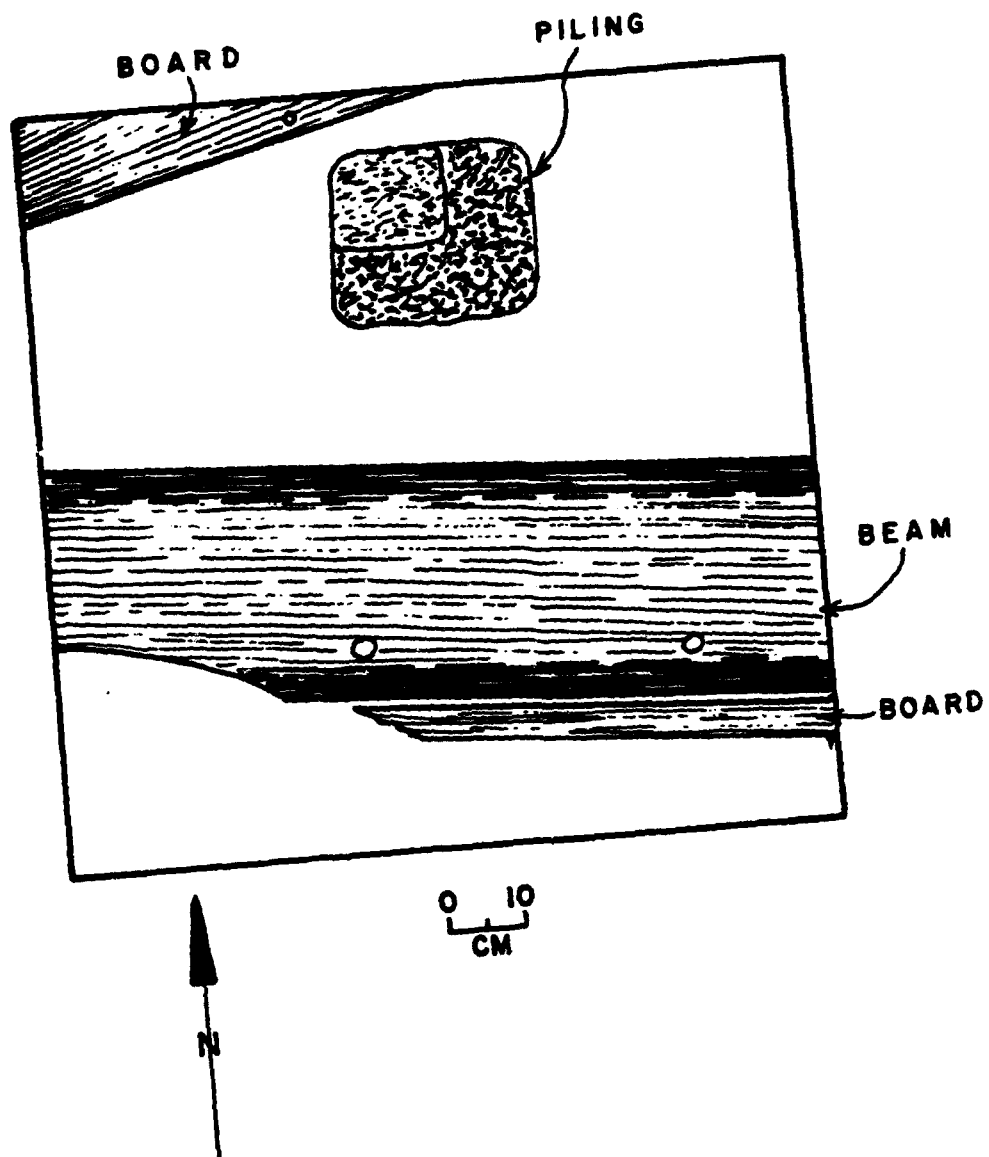
Figure 61. Plan view of Excavation Unit One, western portion, 16OR125, at 50 cm below surface.

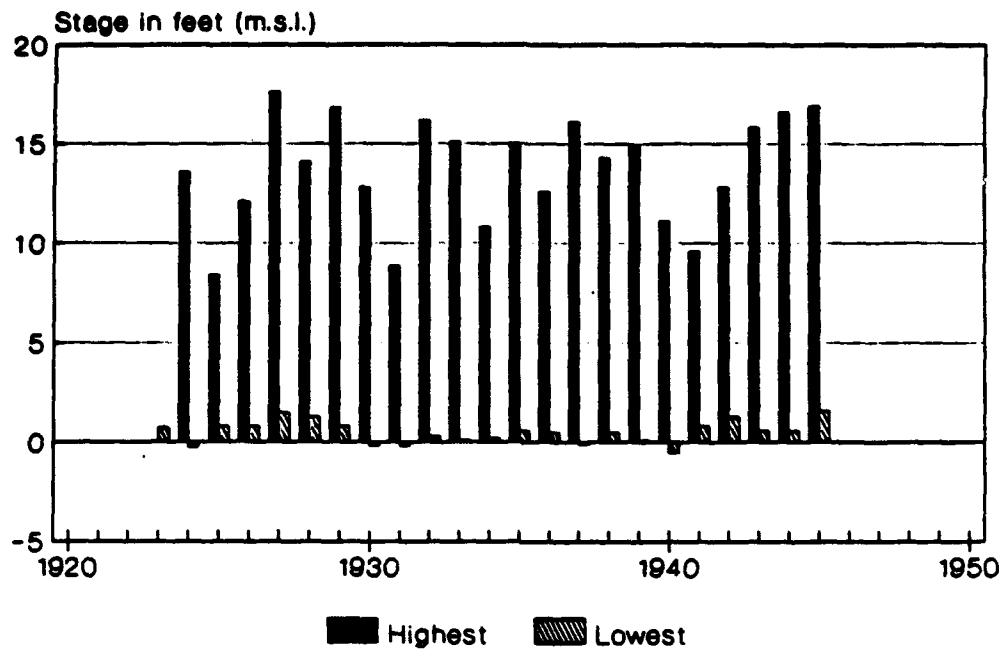
Figure 69. Highest and lowest stages on the Mississippi River at Chalmette: 1922 to 1945 (data source: Mississippi River Commission, 1946).
